Steam Turbine Rotor Vibration Failures: Causes and Solutions

By Farshad Shamoradi, Naser Mohammadi, and Mahdi Heidari Kahkesh, Ahwaz Power Generation Management Co.

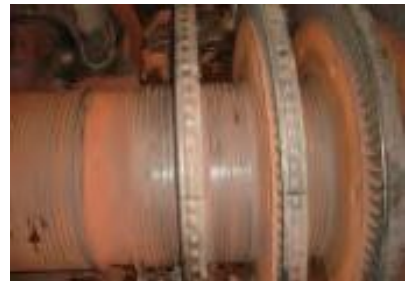
The forces produced by the impact of the large rotating rotor mass with the poorly functioning stationary seals often impress a layer of metal on the surface of the rotor. The rub can cause elastic deformation of the rotor at the point of impact and temporary rotor shaft bending. The shaft bending will usually cause increased vibration levels (Figure 1).

1. Blade rubs cause bending. Rubbing in the sealing of a high-pressure rotor of a 300-MW unit caused bending of this rotor and blade tip rubs. *Courtesy: Ahwaz Power Generation Management Co.*

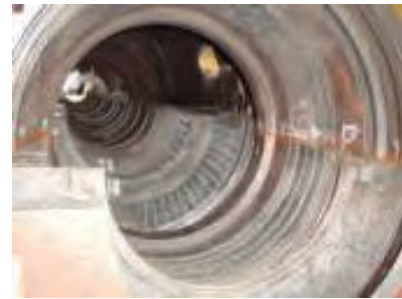
3. Properly align the diaphragms.

the couplings as well as any other factors that may cause change to the primary positions of individual casings, bearing, and rotors. During maintenance, if rubbing is observed at the end or intermediate sealing of the rotor or eccentricity of couplings, it is necessary to realign the driveline to avoid high turbine vibration, contact and rubbing of glands or labyrinth seals, and so on (Figure 3).

The diaphragms must be carefully aligned to the shaft centerline within the casing of this 315-MW turbine to avoid contact with the rotor blades. *Courtesy: Ahwaz Power Generation Management Co.*

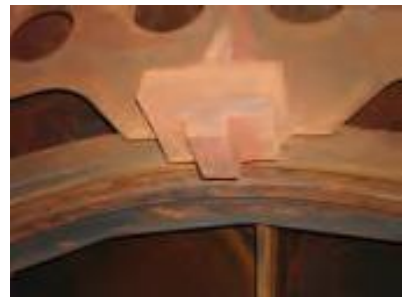
Remember that the axis from the center of the gland's bore should coincide with the axis of the turbine rotor during normal temperatures experienced during turbine operation. Furthermore, it is essential to quickly identify any loss in sealing clearances during steam turbine warm-up. Changes in clearance may occur during warming that could cause bending of the cylinders due to differential temperatures between the upper and lower sections of the cylinder (Figure 4).

4. Precise alignment required. This photo shows the expansion key of the upper half of a low-pressure cylinder. *Courtesy: Ahwaz Power Generation Management Co.*

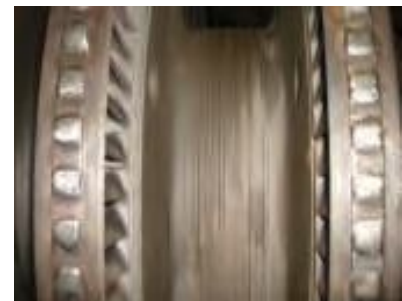
Finally, pay close attention to the possibility of contact rubbing of blade tips on the cylinder walls in reactive stages. Rubbing can cause increased vibration to blade bending, usually at the blade root (Figure 5).

5. Avoid tenon extrusion rubs. This is an example of tenon extrusion in high-pressure rotor blades. *Courtesy: Ahwaz Power Generation Management Co.*

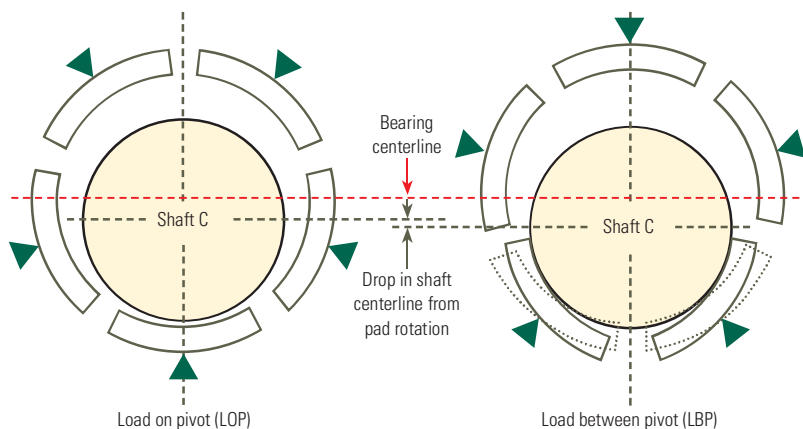
Another factor concerns the difficulty in assembling the HP turbine front bearing. While the shaft is rotating in its journal bearing, the shaft pushes oil from the bottom of the bearing, causing the oil film thickness to change. When this happens, the centerline of the shaft moves up and to one side. To account for this shaft movement, the segmented bearing should automatically adjust and the contact surface of the journal bearing will remain in a good position. If there is too much contact surface, friction will increase on the bearing surface, causing increased rubbing and corrosion of the bearing surface and increasing vibration and rotor eccentricity. The result will be bearing oil leakage and rubbing in the sealing glands. On the other hand, if the bearing contact area decreases, the oil film will cause uneven movement of the rotor within the segmented bearing, and the oil film will not form, also resulting in increased vibration (Figure 2).

2. Shaft must stay centered. Relocation of shaft center in a segmented bearing while rotating can cause vibration. *Courtesy: Ahwaz Power Generation Management Co.*

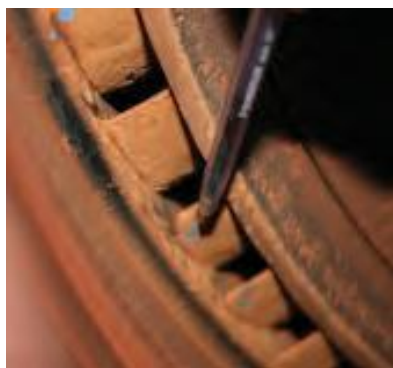
HP steam flowing axially through the turbine cylinder. The magnitude of these stresses is dependent on the flow rate of steam, the temperature drop across the blade stage, the rotational speed of the blades, and the blade weight. The temperature of the steam, superheated in the first stage and saturated in the final stages, will have an effect on the mechanical properties and corrosion of the blade materials (Figure 6).

6. Corrosion causes imbalance. Failure of this high-pressure rotor control stage was caused by uneven distribution of steam due to corrosion. *Courtesy: Ahwaz Power Generation Management Co.*

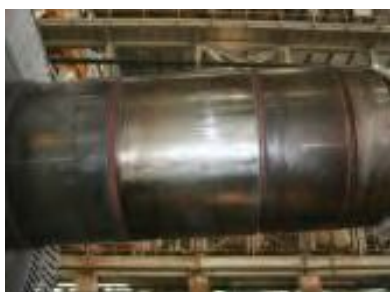
Third, the size of rotary blades and their method of installation on the rotors may be different. After a maintenance overhaul, the same weight and materials of all the blades must be carefully maintained, particularly when only a few blades are replaced. Even a small change in blade weight or center of gravity can cause a rotor imbalance and vibration (Figure 7).

7. Failures can be caused by poor maintenance. This removal of the disk from the rotor was done incorrectly, causing deep scratches on the shaft. The repair will require rework and rebalancing of the shaft to prevent an imbalance that can cause vibration. *Courtesy: Ahwaz Power Generation Management Co.*

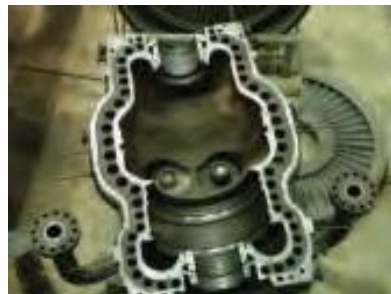
8. Steam can bypass bolts. Large bolts inserted into the holes are used to tightly secure the large horizontal joint flange in this high-pressure cylinder. The bolt holes are places where a steam jet leak can form due to cylinder deformation and changing duct pressures. *Courtesy: Ahwaz Power Generation Management Co.*
